Application Ref: NP/21/0172/TPO

Case Officer	Mike Higgins		
Applicant	Mr Hopkinson, The Beach Court (Saundersfoot Management Co Ltd)		
Agent	Mr Paul Cleaver, Tree Consultants Wales		
Proposal	Fell 1x Monterey cypress (<i>Cupressus macrocarpa</i>) to ground level, leaving stump in situ. (T12 on TPO 33, wrongly identified as a Douglas Fir)		
Site Location	Beach Court, The Strand, Saundersfoot, Pembrokeshire, SA69 9EU		
Grid Ref	SN13790502		
Date Valid	10-Mar-2021	Target Date	16-Jun-2021

The application seeks consent to fell 1x Monterey cypress to ground level, leaving stump in situ.

The tree is protected by Tree Preservation No. TPO 33 (T12) and is incorrectly recorded on the TPO Schedule as a Douglas fir rather than a Monterey cypress.

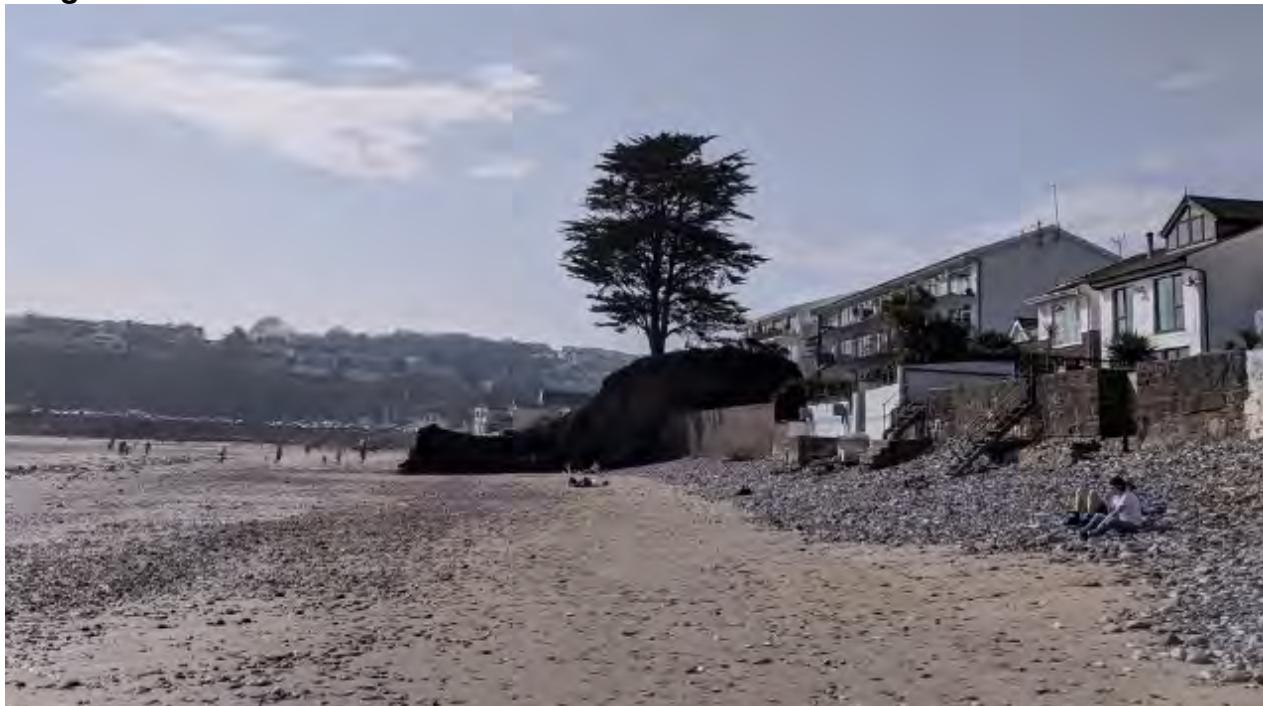
Image No. 1 – Overview of tree

Due to the location of the tree (Image No. 1) it is not possible to remove targets (property / persons) or restrict access to the tree (close off the outcrop and immediate area), and it is the opinion of this officer (and the Arboriculturists involved in this application) that this tree cannot be left unmanaged due to its current condition.

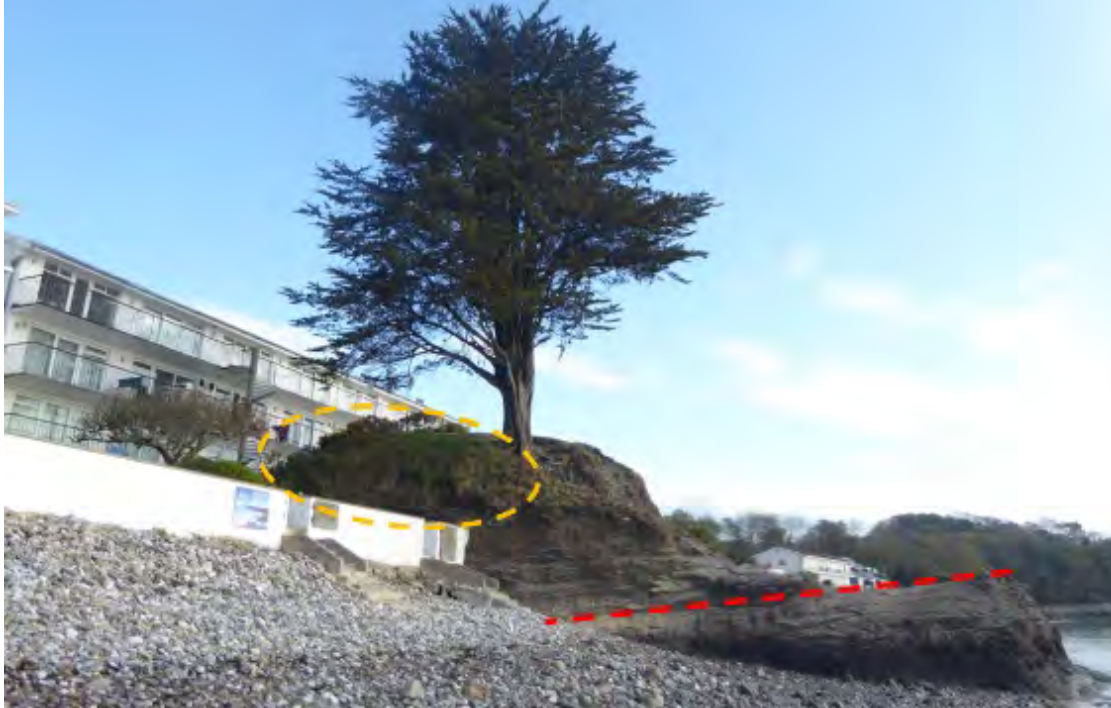
site visits have shown the material directly below the tree to be relatively friable, with a more resilient layer of material at the eastern end of the outcrop (Image No. 3).

Image No. 3 – Material below the red dashed line appears more resilient to coastal exposure than the main body of the outcrop. The orange dashed area shows vegetation on the western side that is more established away from the coastally exposure eastern side. The material (soil horizon and outcrop) between the two highlighted areas appears more susceptible to erosion.

It is unclear whether the outcrop has the structural integrity to support adequate stabilisation methods for the tree and outcrop; however, this has not been explored in this application in order to definitively rule-out retention and management of the tree and/or outcrop.

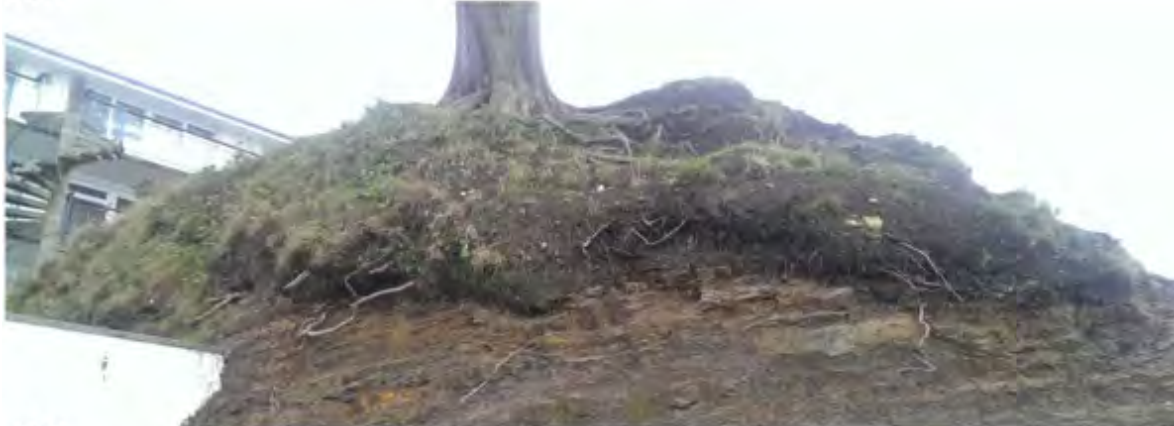
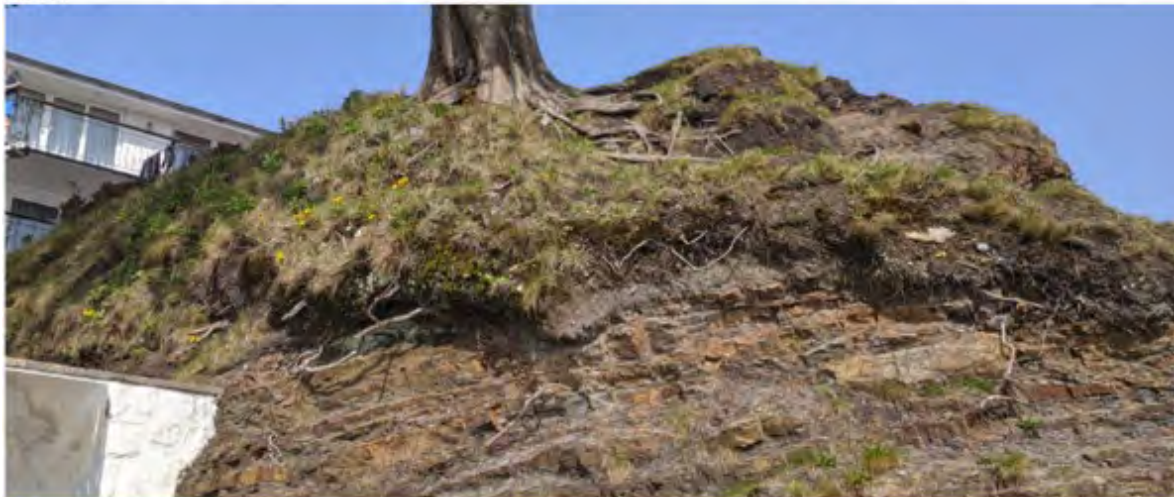
Image No. 5 - Little or no visual change in soil horizon – with majority of reference roots still present.

Recent assessments of the tree by this officer have identified that the advanced erosion of the soil horizon suspected in 2017 is actually relatively stable with little additional erosion observed over the 4 year period.

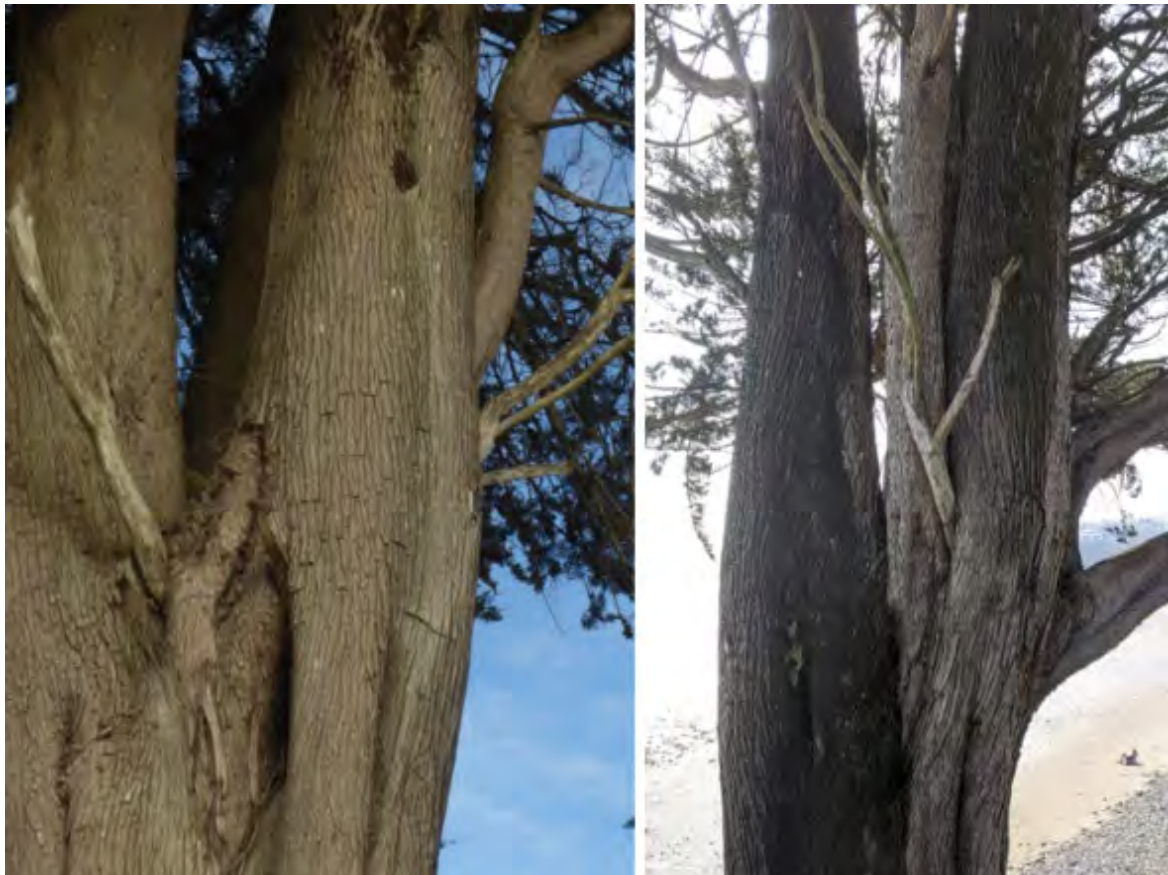
Image No. 6

Main stem union at 3.5 metres with signs of fibre-buckling visible along with included bark

The risk analysis provided suggests that this is most likely to be from failure of the stems (based on size of part). An assessment of the tree, has identified a multi-stemmed union at 3.5 m with included bark and signs of localised fibre-buckling (Image no. 6). Multiple stems is a key structural symptom associated with trunk/stem failure in the species.

The application relates to a multi-stemmed union with included bark and signs of fibre-buckling; which would require further consideration as multiple stems is a key structural symptom associated with trunk/stem failure in the species, although there has been no specific information from the applicant relating to the management of the feature, or information that retention is impractical.

- Inclusive bark at stem unions and signs of fibre buckling on stems – continued subsidence of the stems along with incremental growth could result in failure of the stem union.
- Failure may be expected in extreme weather conditions, but it is unlikely during normal weather conditions within the specified time frame.

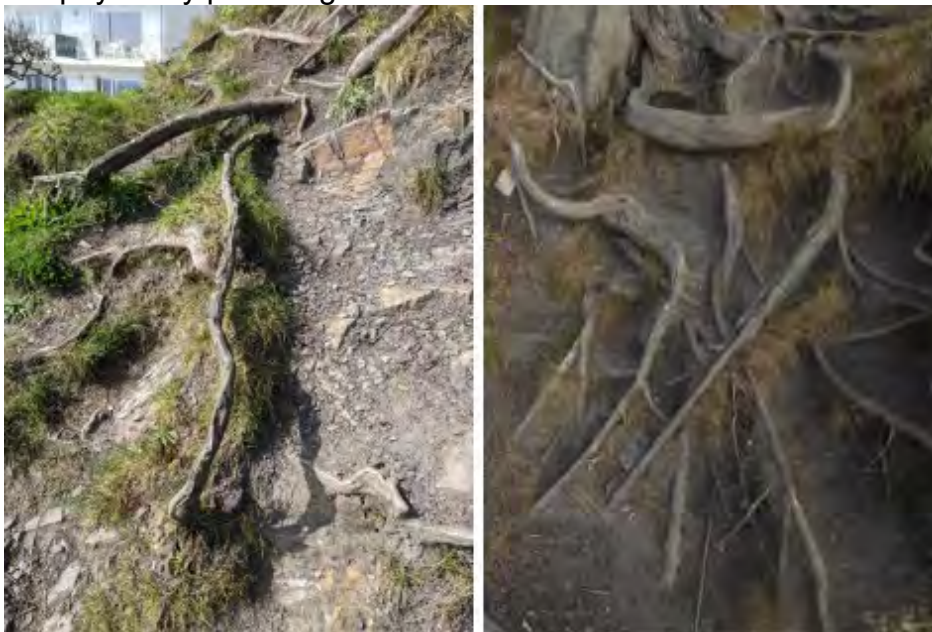
Exposed roots shown growing into soil and outcrop.

Most roots can be seen entering and exiting the surface from grassed or soil areas with only occasional roots growing from cracks within the outcrop. Many are separated from the soil (gaps beneath) which questions the level of support that they are physically providing.

The reinstatement of the lost soil horizon could be acceptable in principle; however, the exposed roots have adapted to their exposure, and as the species is sensitive to waterlogging there are concerns that newly laid, moist mulch could be detrimental to these exposed, adapted roots (Image No. 7) resulting in stress of the root tissues and problems with waterlogging, pests and diseases and rotting of the root zone.

Arb/VTA/112.a report advises that the eroded rooting area can *'be infilled with mature wood mulch and the area of root system be protected with installing turf protect mesh over the surface and secure it with thread pins into the rock strata below, making sure not to damage the structural root system. This will prevent future erosion from foot traffic and maintain a healthier root system.'*

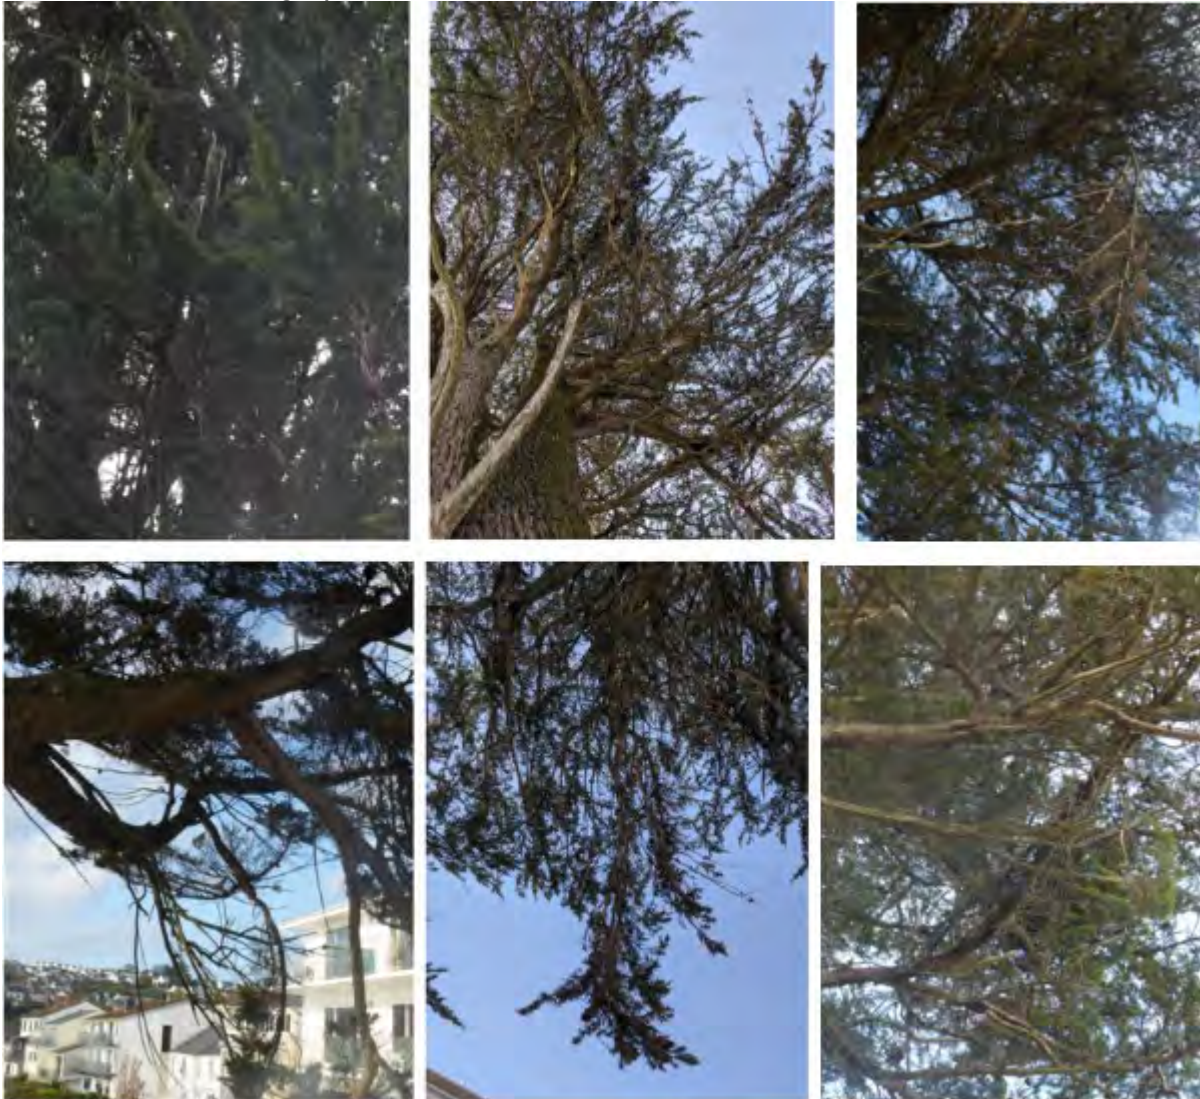
Image No. 8

- Hanging branches present within crown.
- Failure has started or is most likely to occur in the near future, even if there is no significant wind or increased load.
- This is an infrequent occurrence for a risk assessor to encounter, and it may require immediate action to protect people from harm.
- The imminent category overrides the stated time frame.

This particular tree is historically recorded as being over 84 years old and is now showing signs of the most common failure in the species – branch failure. This can be observed throughout the crown with significant branches within the crown having failed and detached, with some branches presently hung-up within the crown (Image No. 8) overhanging public and private areas.

Deadwood and hung-up branches within the crown

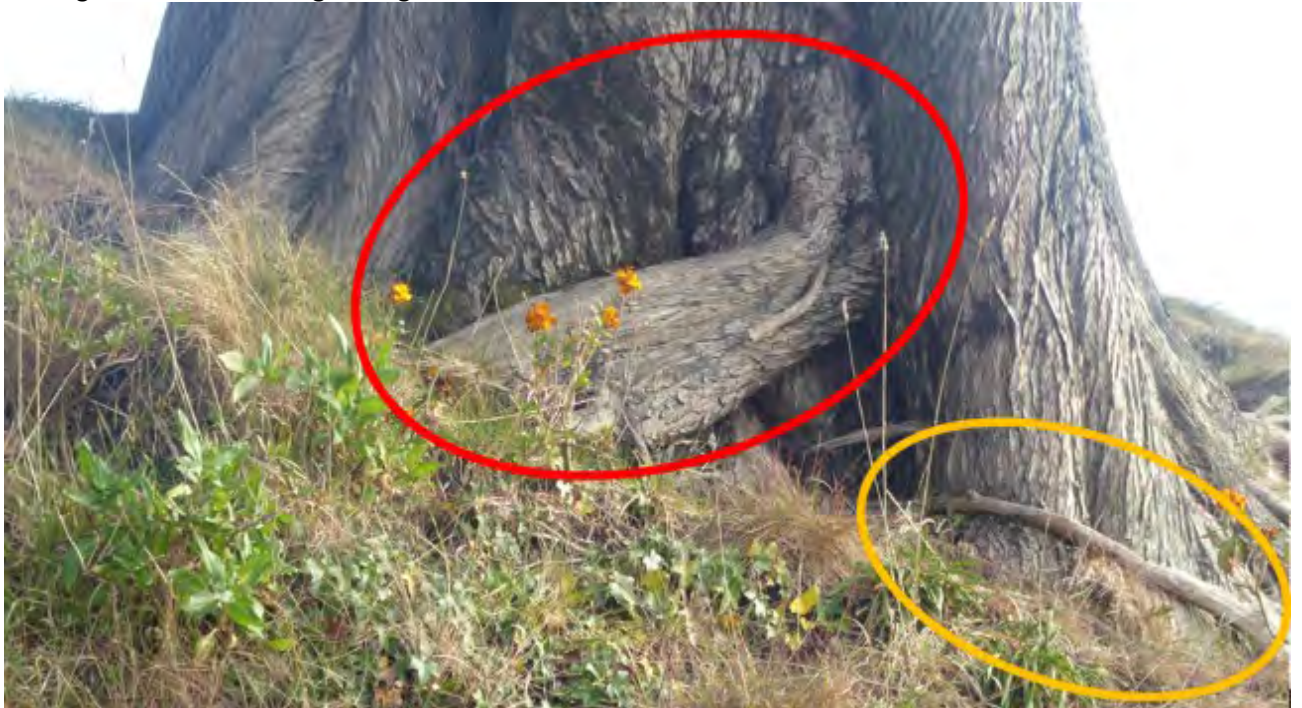
Image No. 9

The second most common failure in Monterey cypress is root failure, with girdled roots a common contributing factor. This particular tree is showing a significant girdled root on the southern side, which appears to have restricted the natural root flare of the tree in the immediate area (Image No.9).

Red circle – Significant girdled root on Southern side of tree

Orange circle - Minor girdling root
