## REPORT OF THE DEVELOPMENT MANAGEMENT TEAM LEADER ON OTHER PLANNING MATTERS

### Tree Preservation Order 146 with objection received

**Reference:** TPO 146 Land Adjacent to Bevelin House, Sandyhill, Saundersfoot

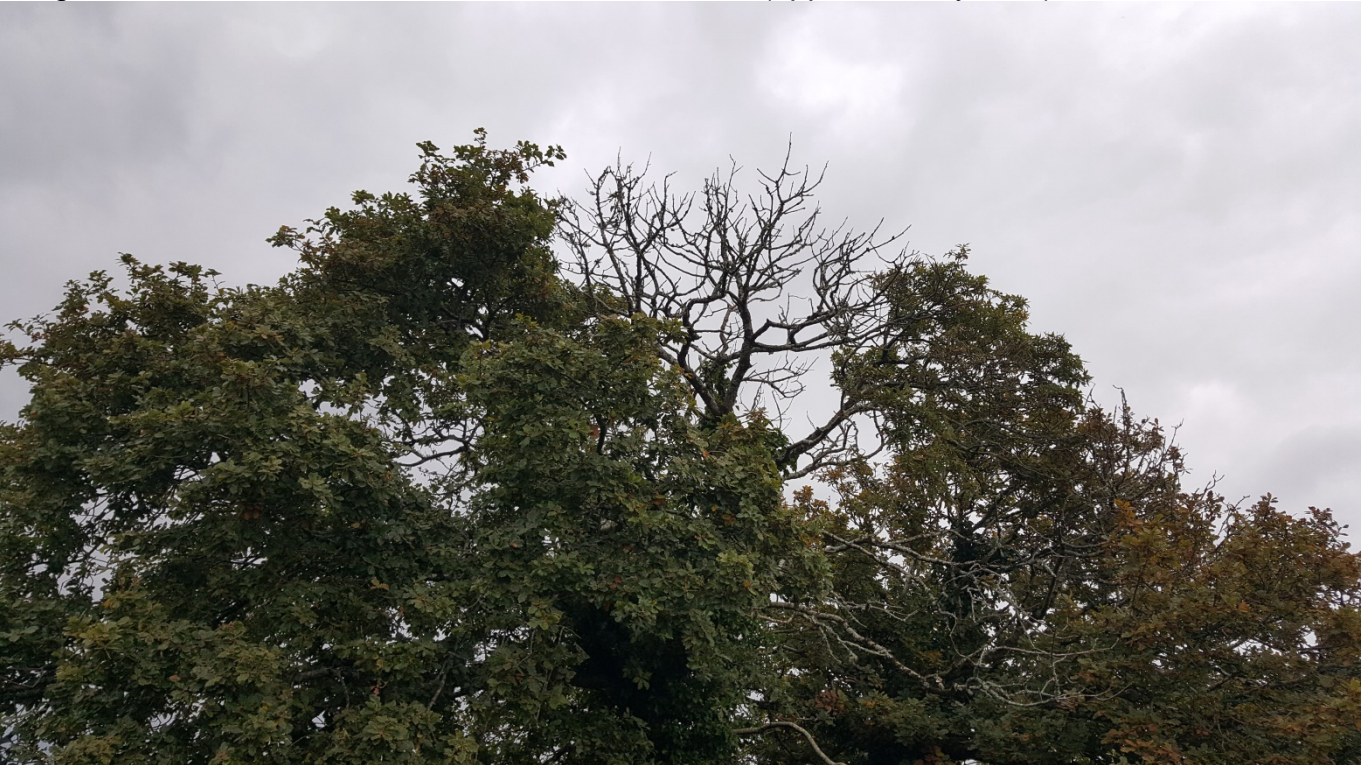
- The consultation process and site visits identified a section of dieback within the crown of Tree 1 (*Image 3*).
- The consultations also identified that a branch failed earlier in the year and there were 'drill holes' present on the trunk.

- In relation to the dieback impacting on the amenity value of the tree; the dieback is isolated to approximately 25% of the crown on the southern side; with the northern side of the crown (visible by the public) in healthy condition with good foliage cover (*Image 4*)

Image 3 – Dieback visible on Southern side of Tree 1 (approximately 25%)

- Oak trees are resilient to dieback and the remedial works can be carried out to manage the crown to account for the dieback without the need to remove the tree in its entirety.

- As such the owner of the tree can carry out necessary works to remove deadwood from within the crown without the need to apply for permission.
- If the owner of the trees is unknown and the trees become a concern in terms of health and safety; Section 23 and 24 of the **Local Government (Miscellaneous Provisions) Act 1976** allows Pembrokeshire County Council to deal with dangerous trees located on private land under exceptional circumstances.

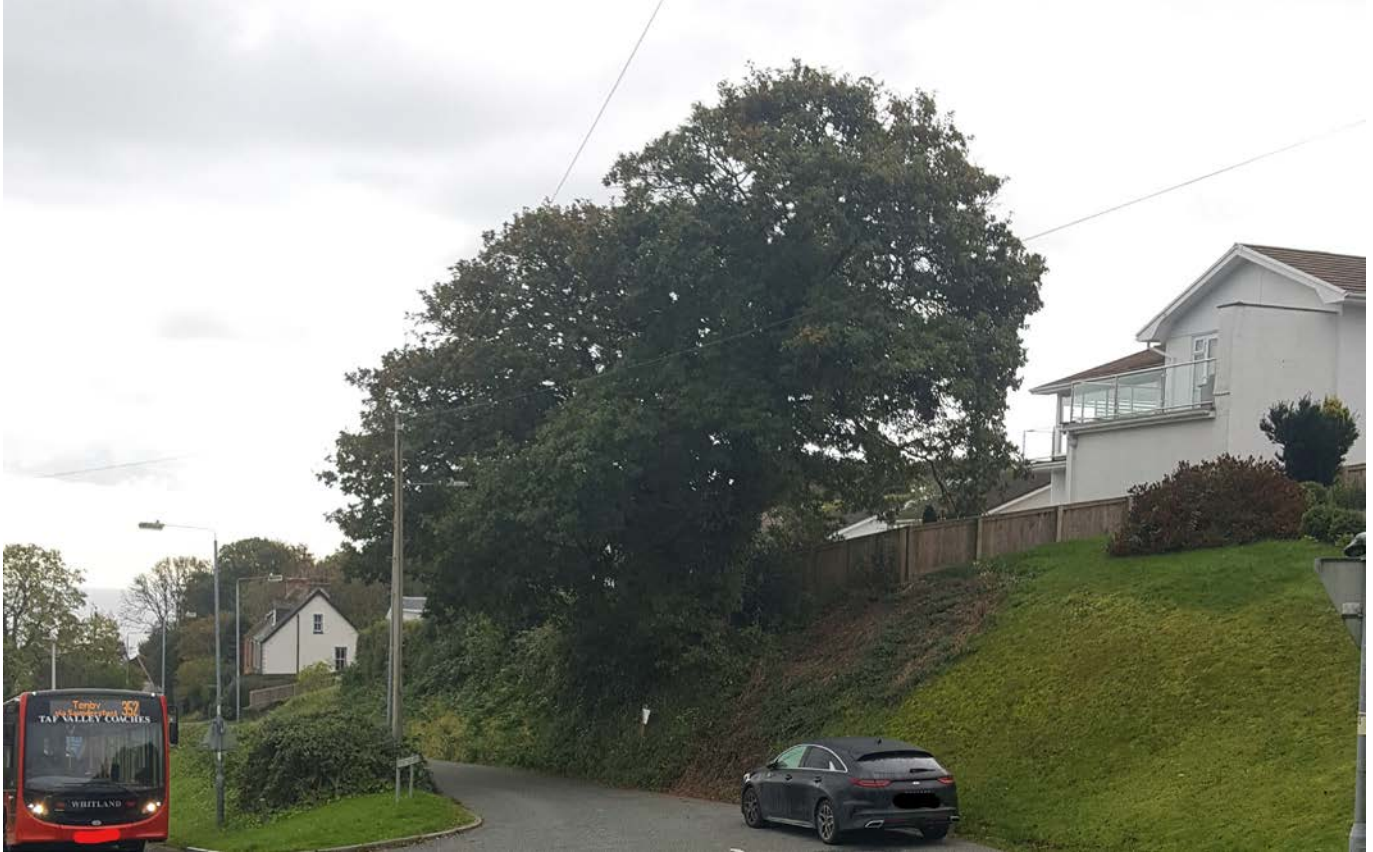
Image 4 – Northern side of crown showing foliage cover

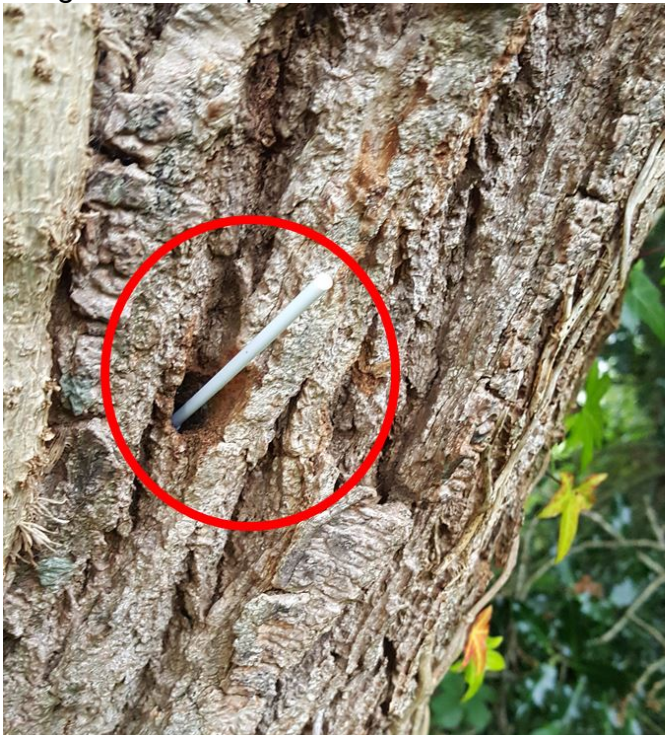
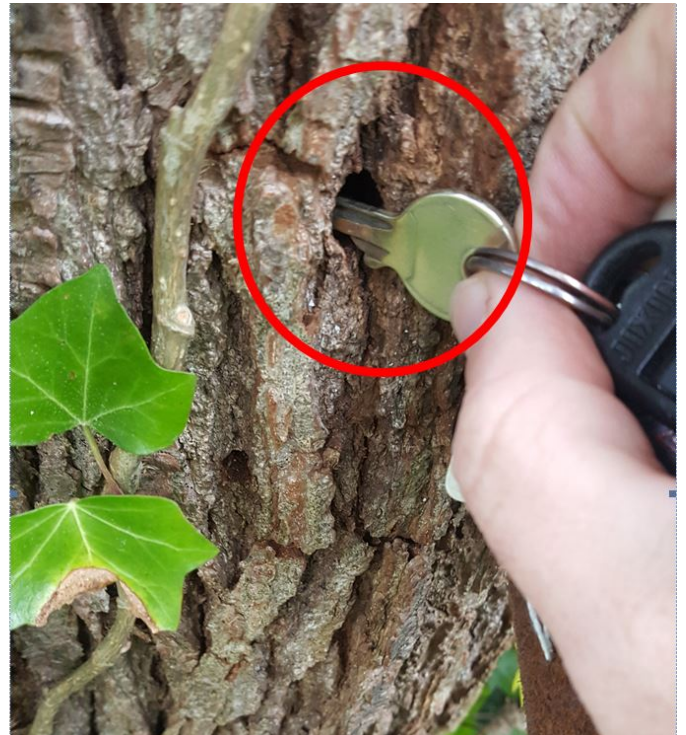
- The tree was examined and holes were found on the southern side of the trunk (*Image 5*); however the cause of the holes is unknown, and whether they have contributed to the decline of the tree would need further detailed investigation.

Image 5 – Holes present in trunk of T1

- If the owner of the trees has a detailed survey carried out on the tree and a Health and Safety concern is identified; actions can be recommended by the tree consultant, with the TPO taken under account at that time.

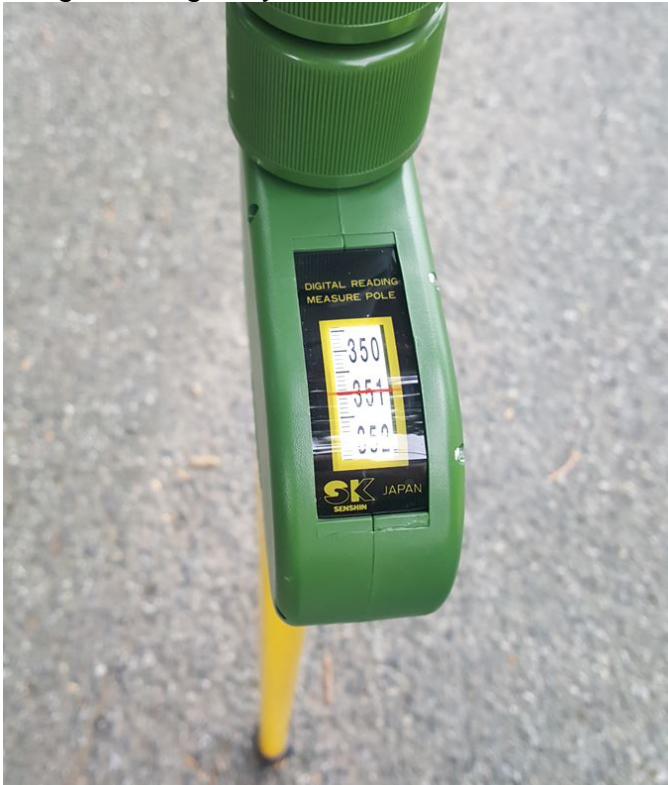
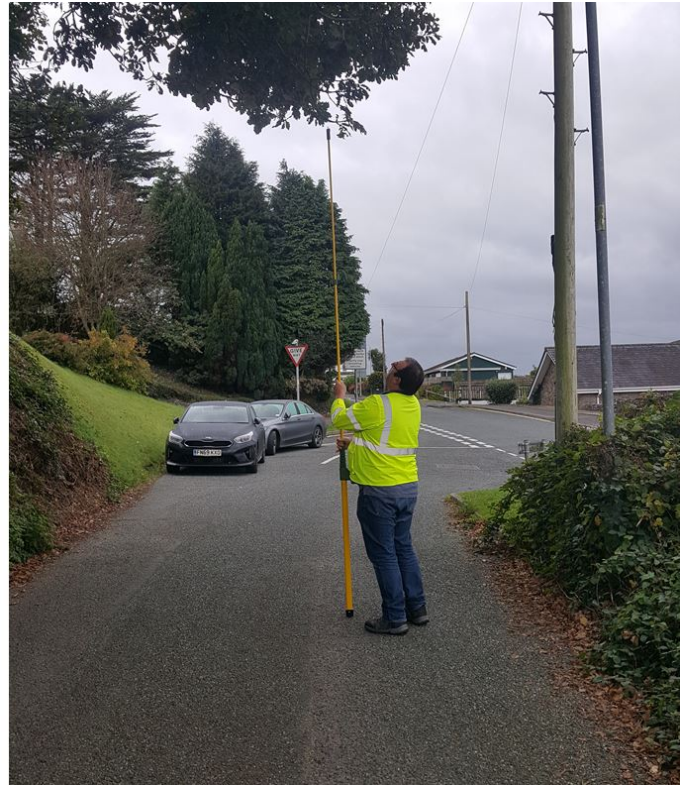
- During a site visit; the clearance from carriageway to the lowest foliage bearing branches was measured by Pembrokeshire County Council and recorded as 351cm. (*Image 6*)

Image 6 – Highway clearance measurement

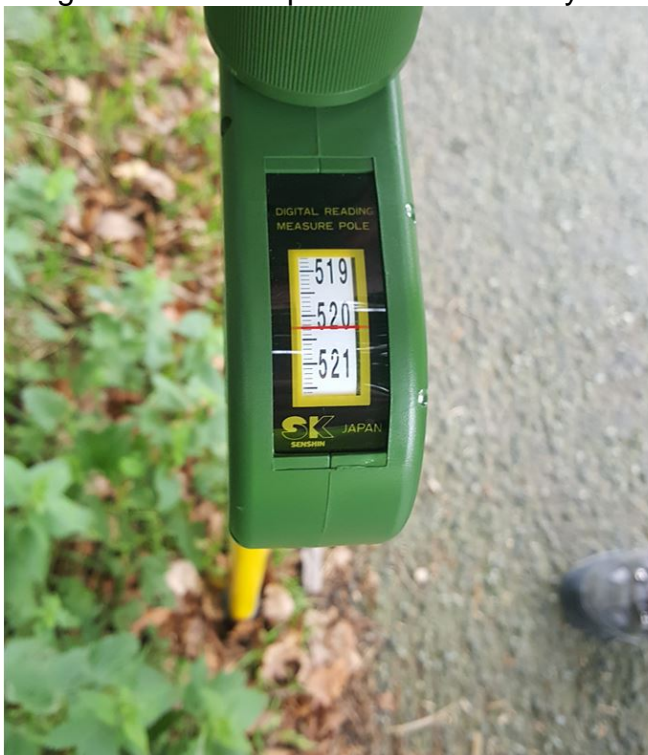
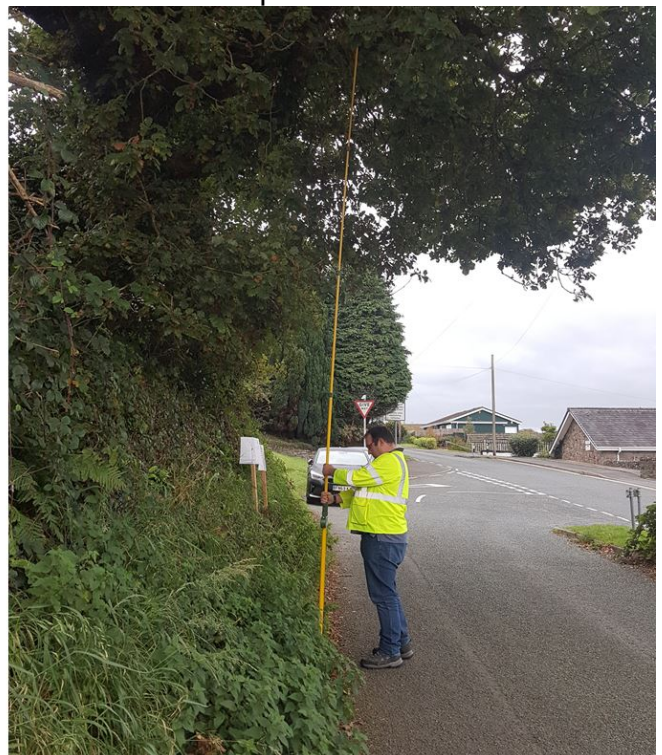
- In order to achieve the recommended 5.2m (520cm) clearance above the carriageway; this distance was also measured, and only minor pruning of branches would be sufficient to facilitate a safe clearance above the carriageway. (*Image 7*)

Image 7 – 5.2m Required clearance only small branches <25mm present below 5.2m

- As such if any proposed work is deemed necessary for the carrying out of necessary Health and safety works in compliance with **Section 154 of the Highways Act**; the Pembrokeshire Coast National Park Authority would have no objection to good arboricultural management of the above trees being carried out.

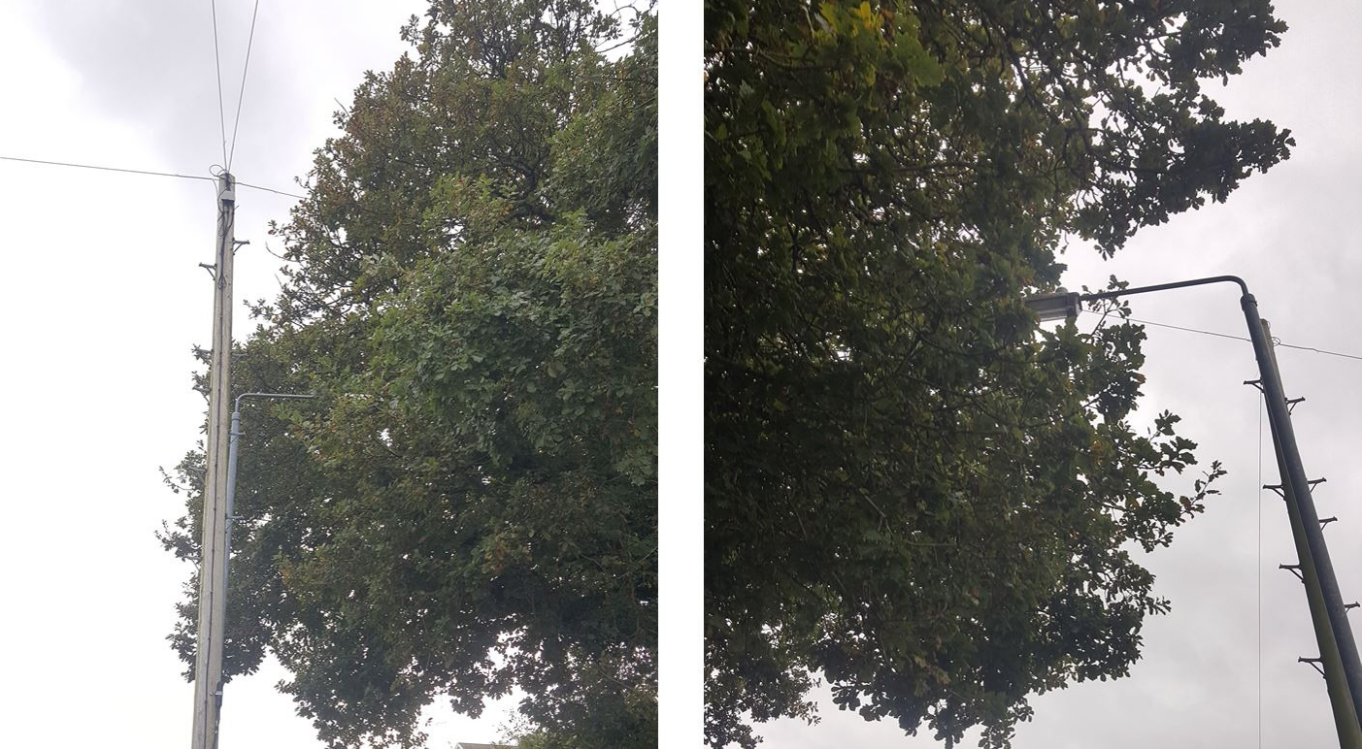
- If the trees interfere with the street lighting installed in proximity to the tree; the relevant authority can be contacted such as Pembrokeshire County Council, and if a report by a tree professional or engineer/surveyor identifies the tree as an issue, this can be dealt with accordingly.
- During a site visit; the clearance from the street light to the closest foliage bearing branches was considered and only minor pruning of branches would be required to ensure that the streetlight was not obscured by the foliage of the adjacent trees (*Image 8*)

Image 8 – Foliage in proximity to Streetlight – Images taken from both sides of street light  
Telecommunications cables also visible

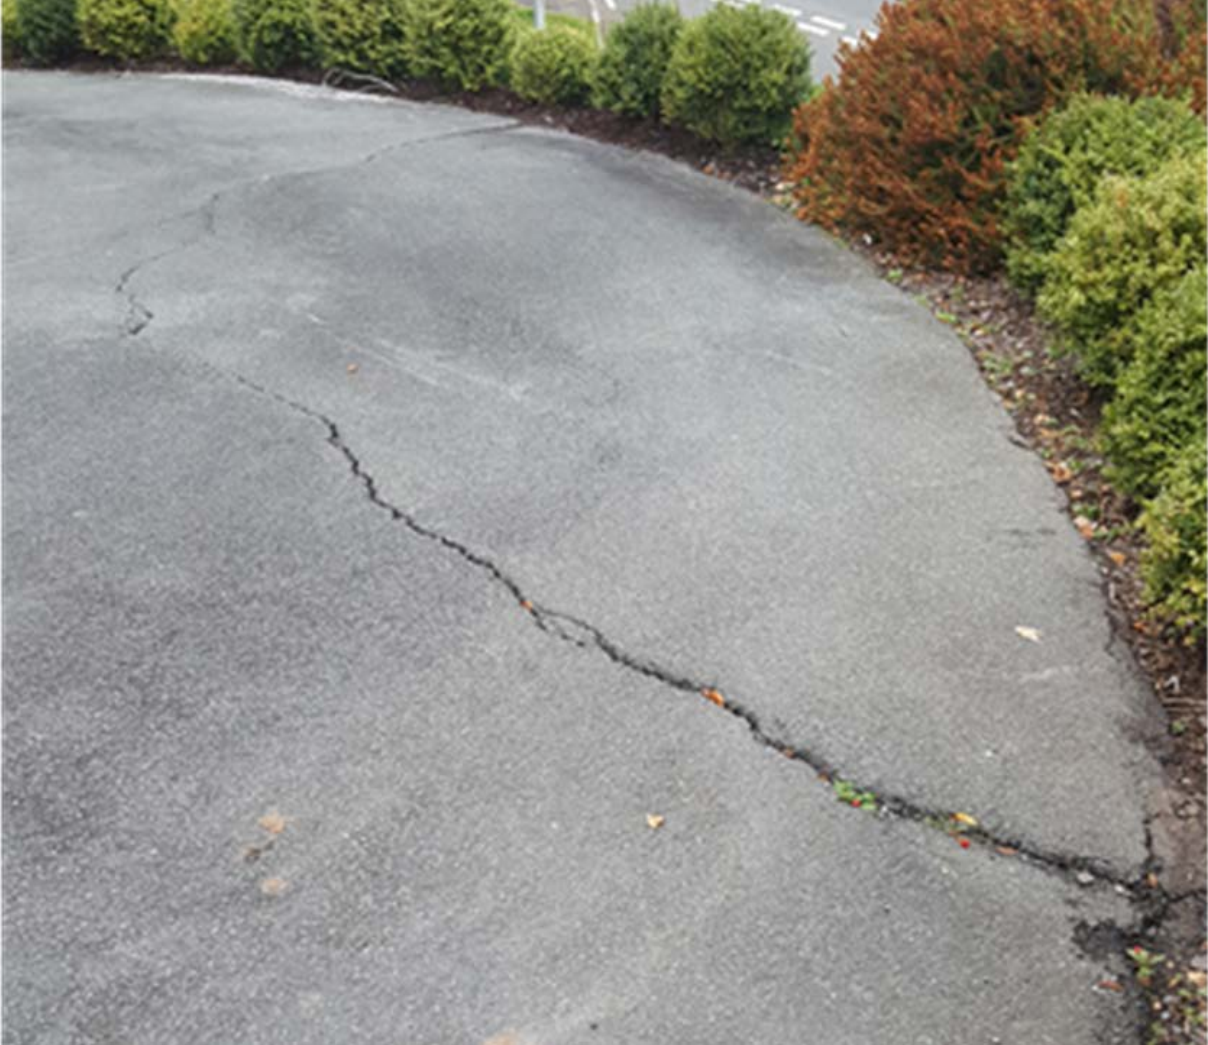
- This matter would not be a planning consideration; other than to consider mitigating works under a TPO application, should it be required.
- Cracks in the driveway were evident during the site visit (*Image 9*), however it was not possible to define the cause of the cracks.

Image 9 - Crack visible in driveway – Tree is located to the right of the image.

- Where damage (legal nuisance) is considered an issue; it is advised that legal advice is obtained.
- A TPO does not prevent works being carried out in accordance with Health and Safety.

- If an issue has been adequately identified through assessment by a tree professional/structural engineer; then suitable measures can be taken.
- It would not be reasonable to remove the tree if such damage is far off, remote and not immediate.
