**Application Ref: NP/16/0630/LBA**

<b>Case Officer</b>	Rob Scourfield		
<b>Applicant</b>	Picton Castle Estate		
<b>Agent</b>	Mr M Vines Acanthus Holden Ltd		
<b>Proposal</b>	Conservation and restoration of historic garden buildings and ancillary structures including reinstatement of glasshouse, to provide improved public access and interpretation		
<b>Site Location</b>	Picton Castle Walled Garden, The Rhos, Haverfordwest, Pembrokeshire, SA62 4AS		
<b>Grid Ref</b>	SN00851342		
<b>Date Valid</b>	01-Dec-2016	<b>Target Date</b>	25-Jan-2017

Project: PICTON CASTLE WALLED GARDEN

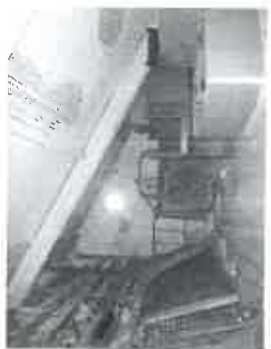
BOTHY

**BOTHY AND FORMER SHOPS.** Internal walls including ceiling and secondary walls not to be removed, repaired or reconstructed (over), but may require re-pointing where visible, within 1700. Two separate ground levels. Floor levels are to be confirmed by survey. The former shop is to be demolished. The existing chimney requires re-build from South elevation of both walls. Three lighting, surface mounted ceiling, 1 fixture inside within structure. Fixtures over asphalt falls level.
