REPORT OF THE DEVELOPMENT MANAGEMENT TEAM LEADER ON ENFORCEMENT AND OTHER MATTERS

Reference: EC/16/0044

Site Address: Medical Hall, Tudor Square, Tenby SA70 7AD

Breach: Unauthorised works to a listed building

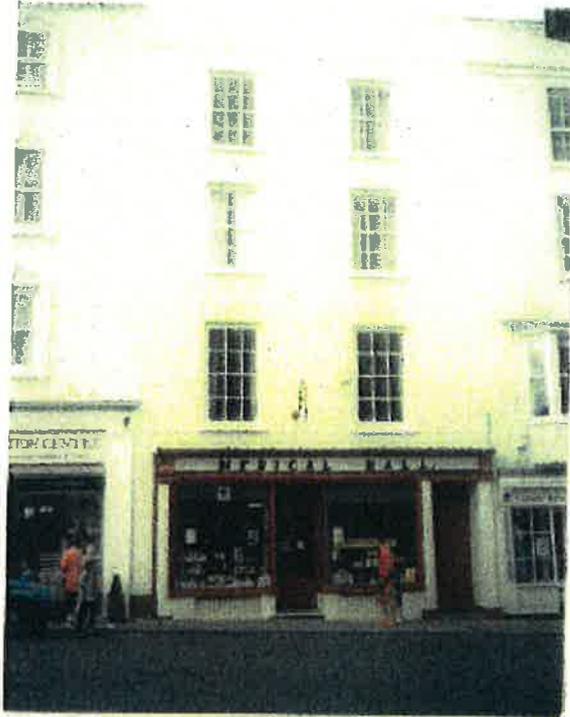
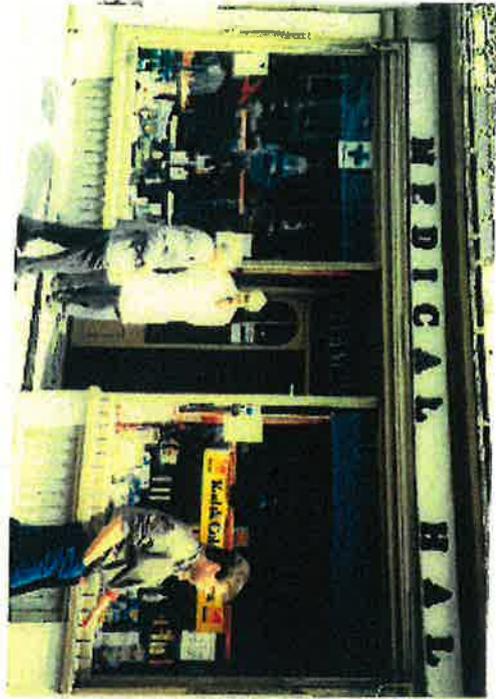
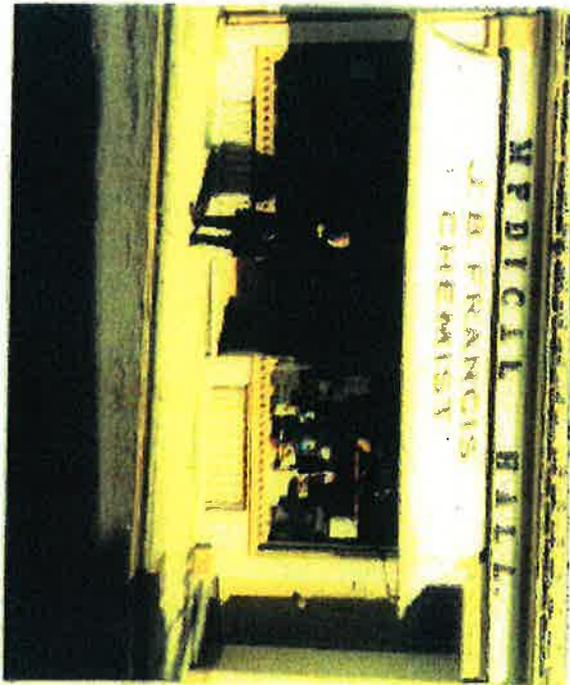
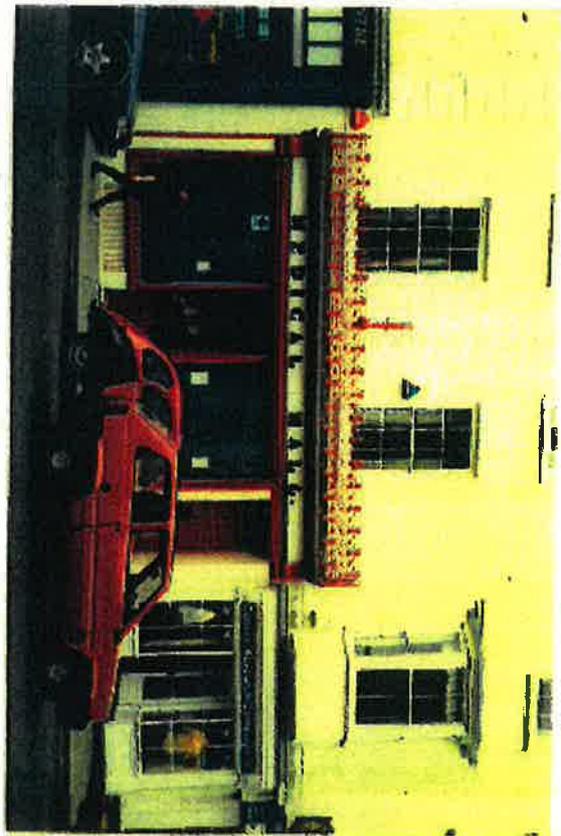
1. The replacement of the shop door from paired doors to a single door as shown on Photograph A.
2. The alteration of the fixtures to the rear wall of the shop interior noted in the list description as 'three-bay feature with doorways left and right and broad centre

Photograph A – Shopfront prior to alteration showing paired doors

- a. The reinstatement of the paired shop doors as shown on Photograph A
- b. The reinstatement of the former finish of fixtures to the rear wall of the shop interior noted in Photograph B and the list description as 'three-bay feature with doorways left and right and broad centre with carved wood frame and glazed lettered panels 'James' Pharmaceutical Chemist' under scrolled pediment', namely the reinstatement of the stained finish, and removal of the vinyl overlays from the glazed panels.
- c. The reinstatement of the drawers to the rear wall of the shop as shown on Photograph C.
- d. The reinstatement of the fixtures to the right-hand wall within the shop, noted in the list description as having 'drawers with names of chemicals, and pilaster framing for shelves' and shown on Photographs D

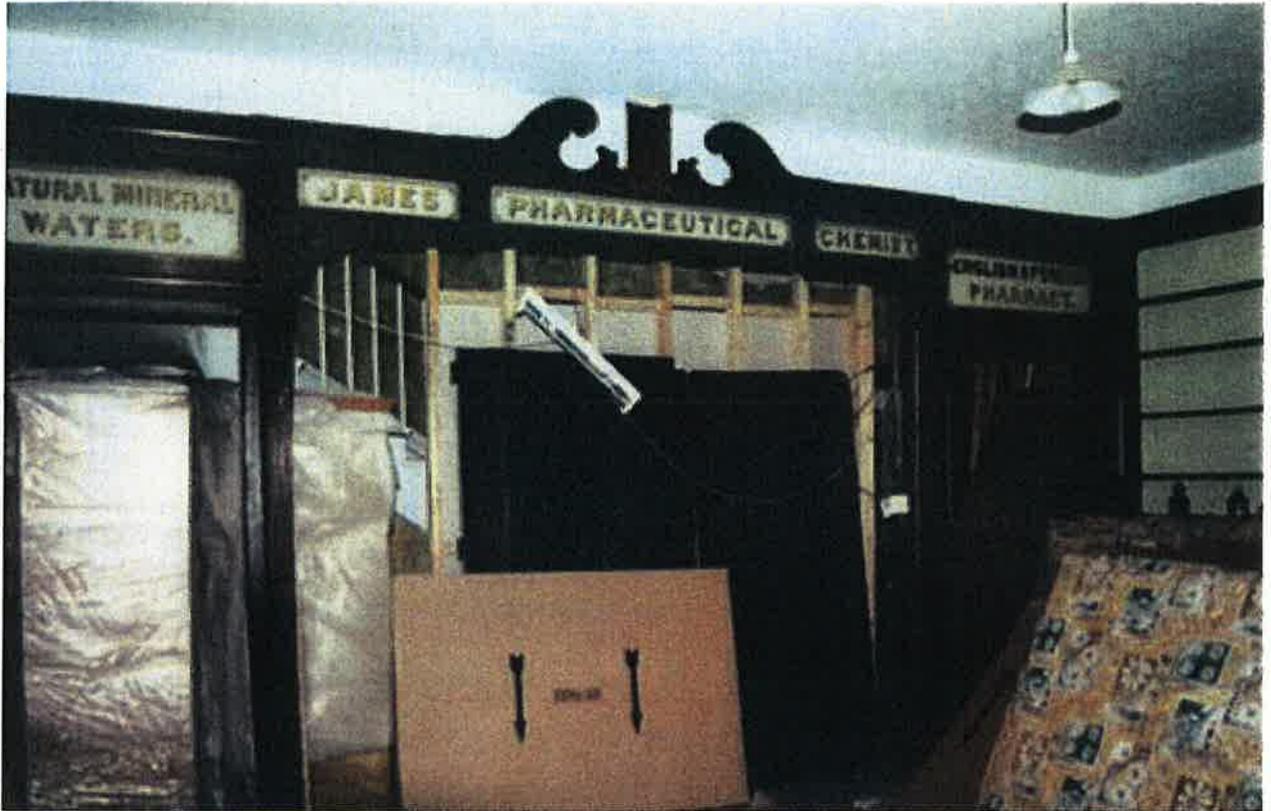
with carved wood frame and glazed lettered panels 'James' Pharmaceutical Chemist' under scrolled pediment' and shown on Photograph B. The alterations include the application of white gloss paint and the application of vinyl overlays onto the glazed lettered panels.

Photograph B – fixtures to rear wall of shop showing historic finish and exposed insets

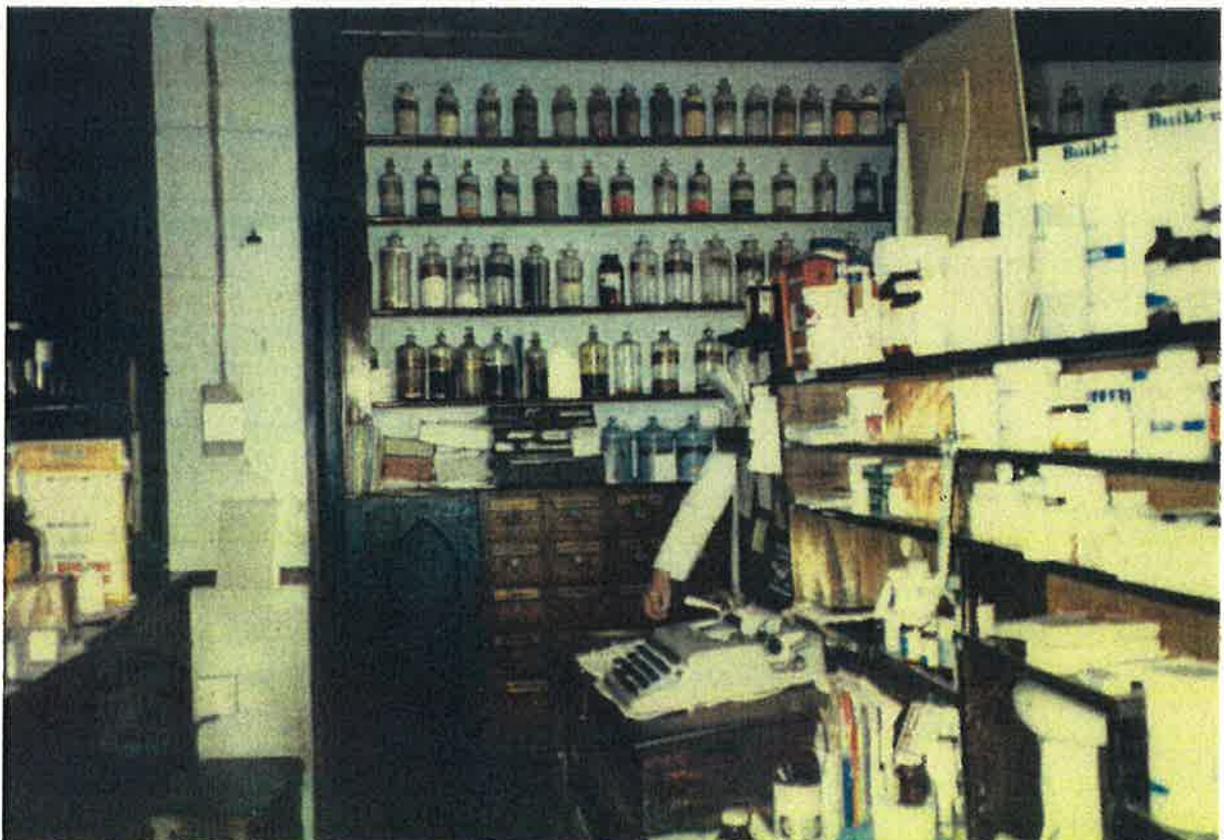
3. The loss of the drawers to the rear wall of the shop as shown on Photograph C.
4. The alteration of the fixtures to the right-hand wall within the shop, noted in the list description as having 'drawers with names of chemicals, and pilaster framing for shelves' and shown on Photograph D.
5. The alteration of the internal walls of the shop by the application of laminate panelling and illuminated panels as shown on Photograph E
6. The alteration of the door threshold comprising a panel of steel tread-plate as shown on Photograph F
7. The removal of the historic raised fascia lettering to shopfront as shown on Photograph G

Photograph C – fixtures to rear wall of shop (shown on left) prior to removal

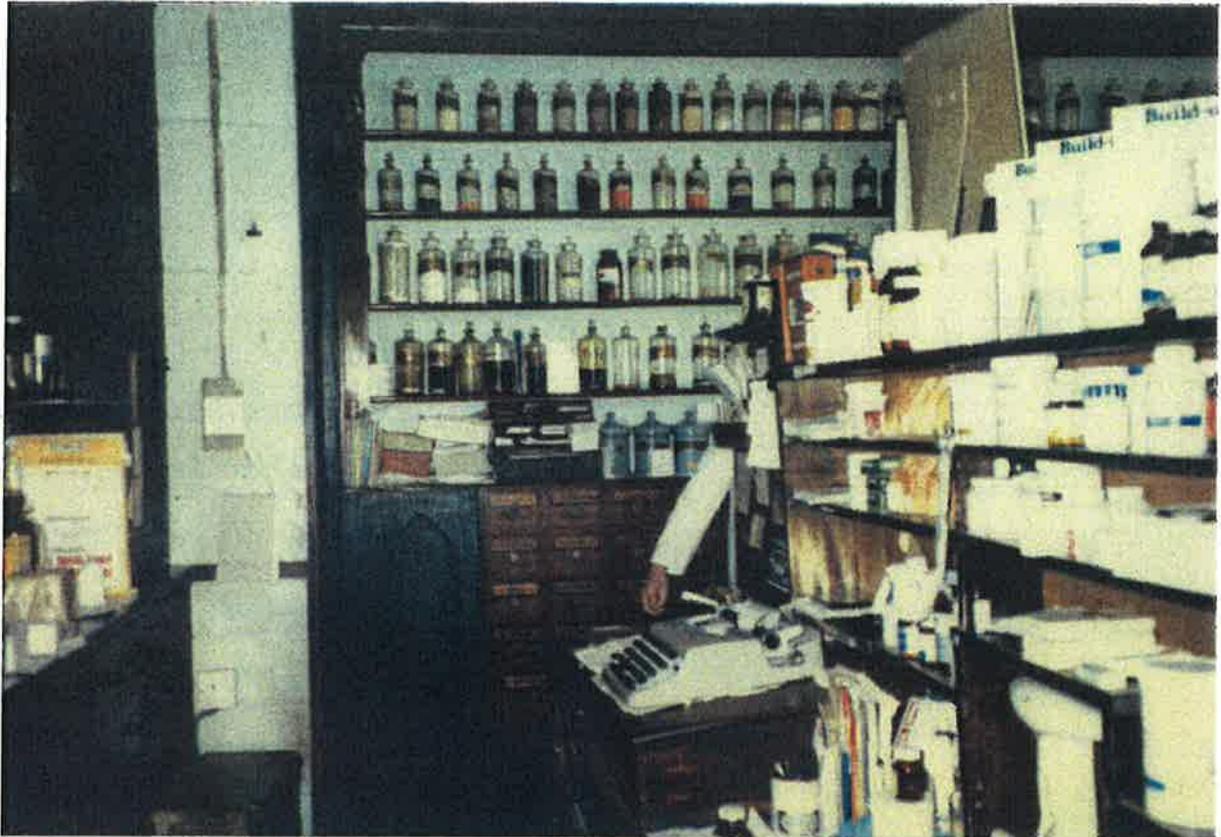
Photograph D – fixtures to right-hand wall of shop prior to removal

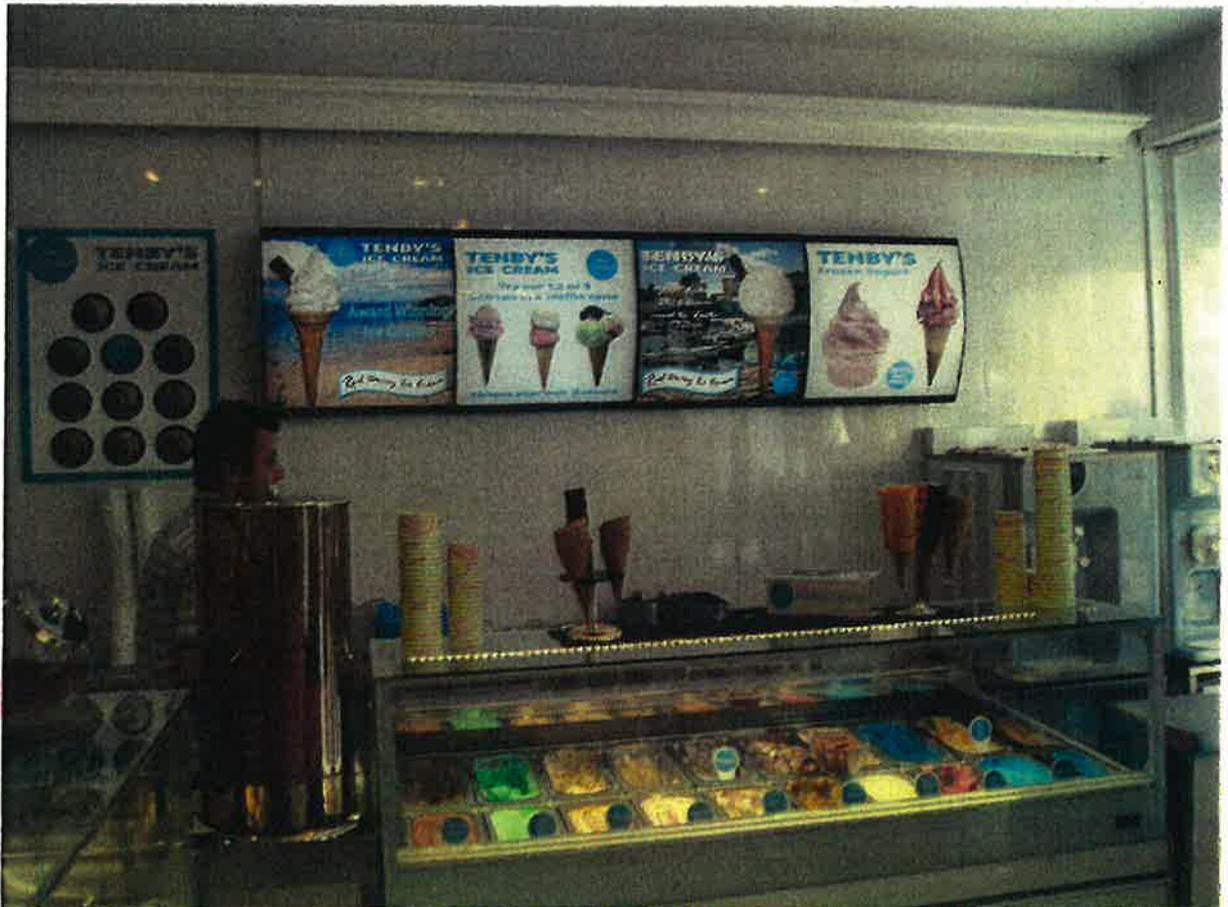
Photograph E – paneling and illuminated panels installed 2016

- e. The removal of the alteration of the laminate panelling and illuminated panels from the internal walls of the shop, as shown on Photograph E.
- f. The removal of the steel tread-plate from the shop door threshold as shown on Photograph F
- g. The reinstatement of the raised fascia lettering as shown on Photograph G
- h. Make good any damage caused to the Building by carrying out the above

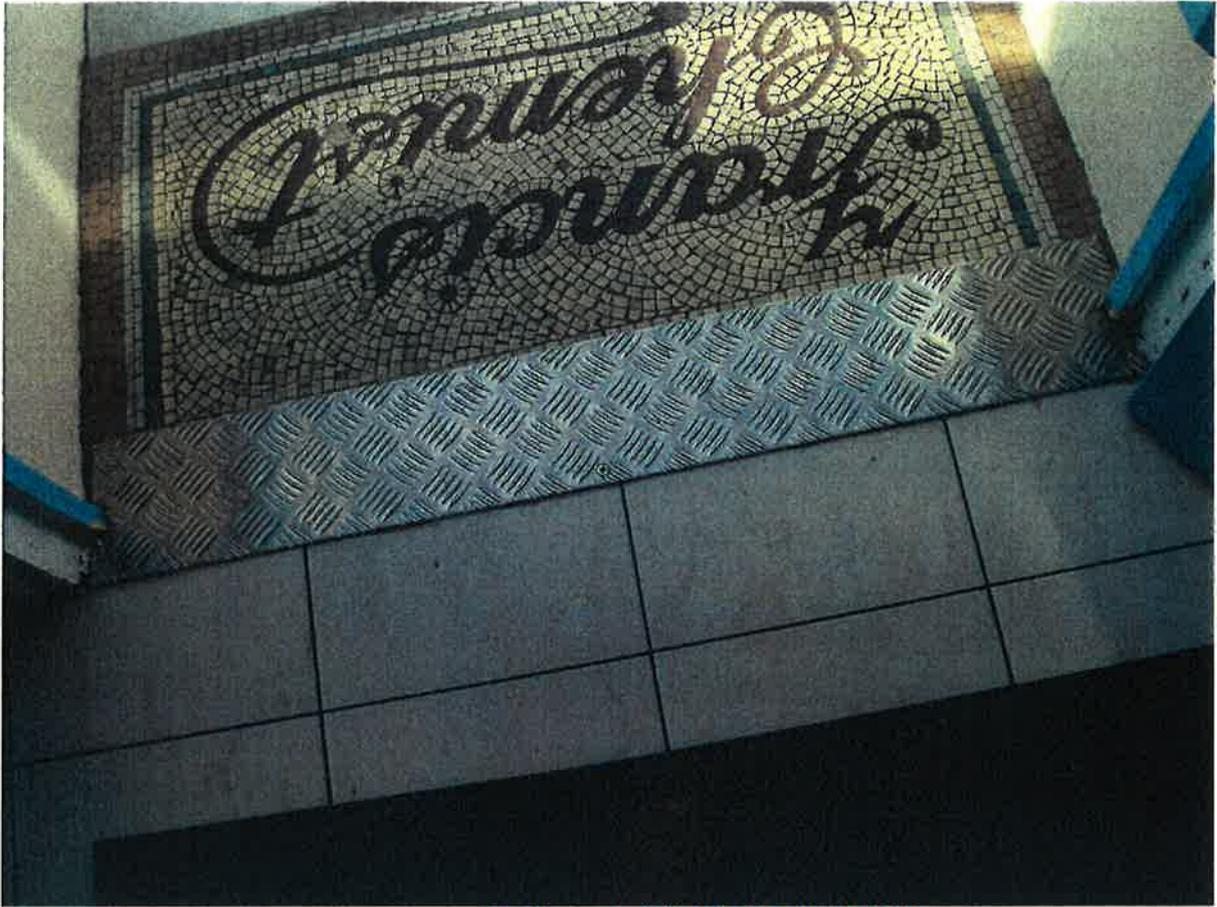
Photograph F – steel plate installed to threshold 2016

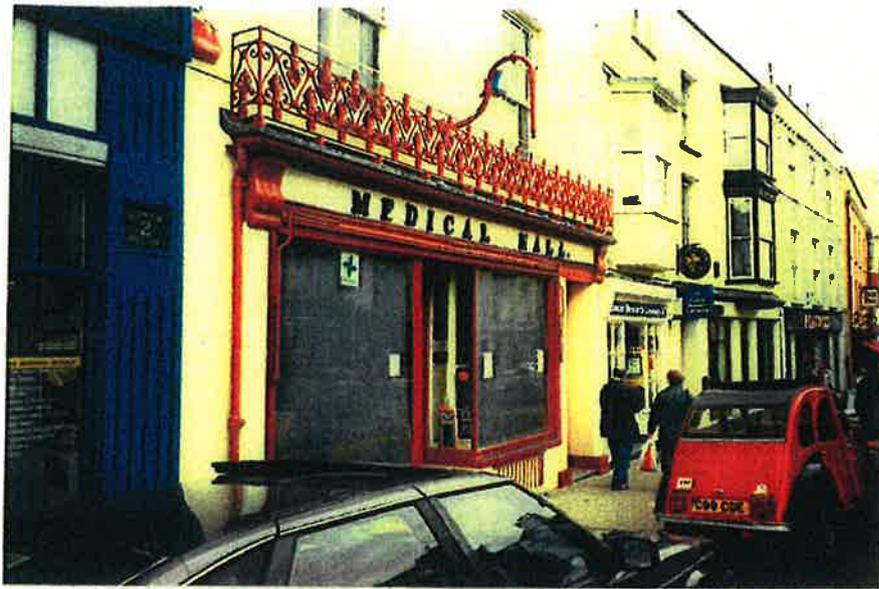
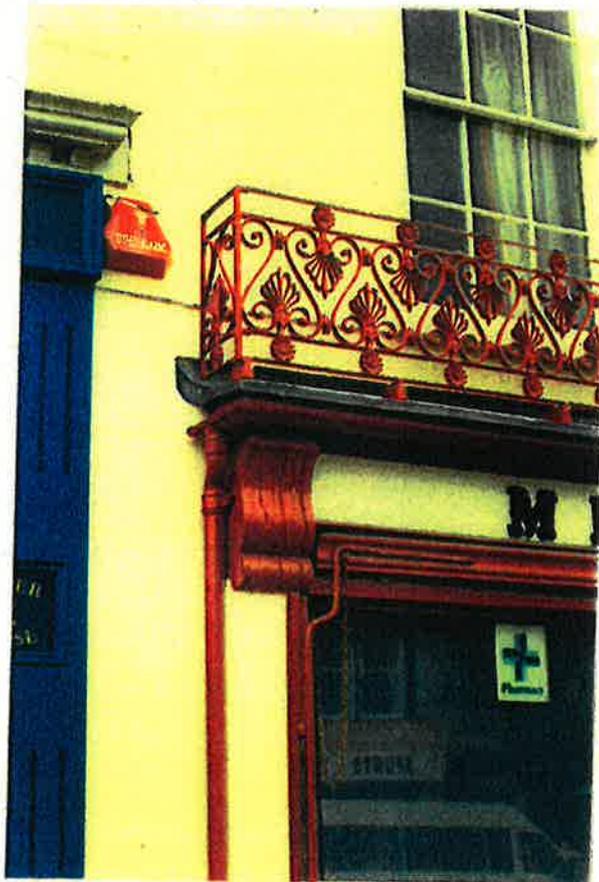
Photograph G – raised lettering to fascia prior to removal
